Raman spectroscopic analysis of a belltower commemorative wall decoration

Abstract The Raman spectroscopic analysis of a rare wall decoration in a church belltower, depicting the initials of couples married there in circular roundels over some 230 years, since 1777, has been undertaken prior to their impending restoration. The spectral data indicate that the red pigment is exclusively haematite which has been applied to plaster which exhibits the signatures variously of calcite, gypsum, anhydrite, calcium phosphate and dolomitic limestone; evidence of amorphous carbon is attributed to the deposition of soot from candle illumination, which has been recorded in historical documentation. The presence of biosignatures attributed to carotenoids in several samples is evidence of biological colonisation and potential deterioration which requires special treatment in the restoration strategies. The blackened areas near the upper edges of the wall decoration indicate carbon deposition and organic contamination. The latest addition to the decoration accomplished in 2008 shows that haematite has been used over a calcite ground. In earlier dated specimens, the presence of limewash is evident,

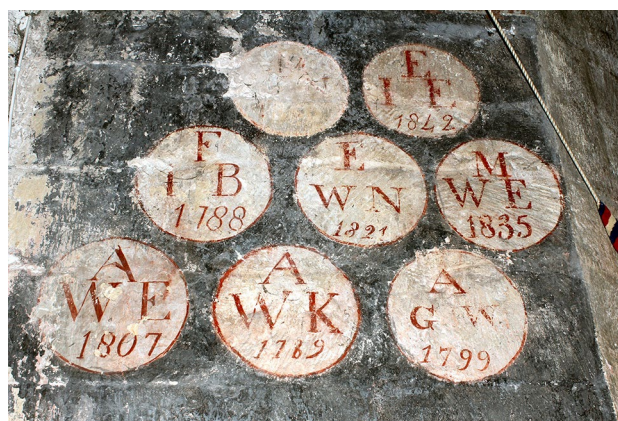
Fig. 2 “Cheese” decoration showing evidence of blackening and degradation

4. The analyses of the extensively blackened and green-stained areas, seen in Figs. 2 and 3, show rather more

complex spectra with features recognisable from carotenoids, chlorophyll and other organic compounds, which indicates that biodeterioration has occurred in these areas [51–53]. This is also noteworthy in the “cheese” from 1799. The carotenoid is probably beta-carotene and reflects cyanobacterial or lichen colonisation of the affected areas and this is particularly prevalent in the border-blackened areas.

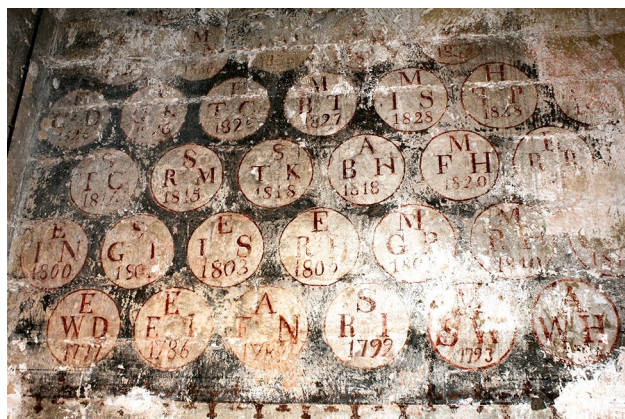
Fig. 1 St Peter's Church, East Drayton, “cheese” wall decoration in the belltower

In the current study, we report the results of Raman spectroscopic analytical work undertaken upon a rather unusual wall decoration which has been added to over a period of some 230 years: the wall of the bellringers' loft in the bell tower of East Drayton church in Nottinghamshire in the UK has commemorative and dated circles (locally known as “cheeses” or “cake rings”) [41–45] which contain the initials of the bride and groom who have been married in the church (Figs. 1, 2). The earliest date recorded is 1777, up to 1865, after which in 1873 the ringers' loft was dismantled and ringing took place from the ground floor, with the painted area inaccessible until the ringers' loft was reinstalled in 1952. The latest “cheese” dates from 2008. The palette is apparently very simple and the decoration is applied in red over a creamy-white ground, covering the period from 1777 to 1865 with the latest “cheese” dated 2008, so overall

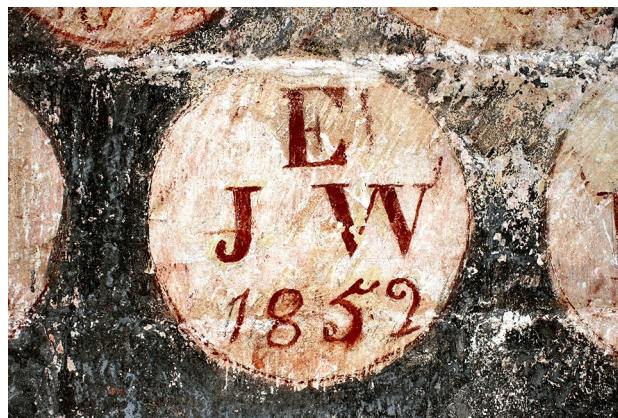
Fig. 3 Detail of the 1852 “cheese”

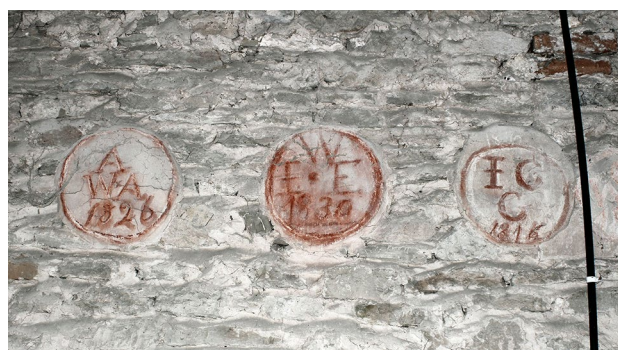
Fig. 4 St Peter’s Church, Laneham, “cheese” decoration in belltower

The nearby medieval church of St. Peter, Laneham, 4 km to the north-east, also has a set of similar “cheeses” in the ringing chamber of the tower, although far fewer than at East Drayton and within a much more restricted date range, with visible dates running from 1816 to 1837. Some of these “cheeses” are shown in Fig. 4.

A final comment should be made about preliminary analyses which were similarly carried out on three Laneham church “cheeses” dating from 1816, 1825 and 1830 (Fig. 4), where the pigment in the 1816 cheese shows the presence of goethite, whereas that in the two others is strictly haematite; the substrates are calcite for the first two samples and bassanite for the 1830 sample—which is the only one to also show the presence of soot. The presence of goethite in the earliest example could indicate that a mixture of goethite and haematite was used here or that goethite was heated to produce the desired colour—upon heating to 300 °C goethite transforms into haematite, with a consequent variation in colour occurring from yellow to orange-red—with such a procedure residual goethite often can be detected in the haematite pigment used.

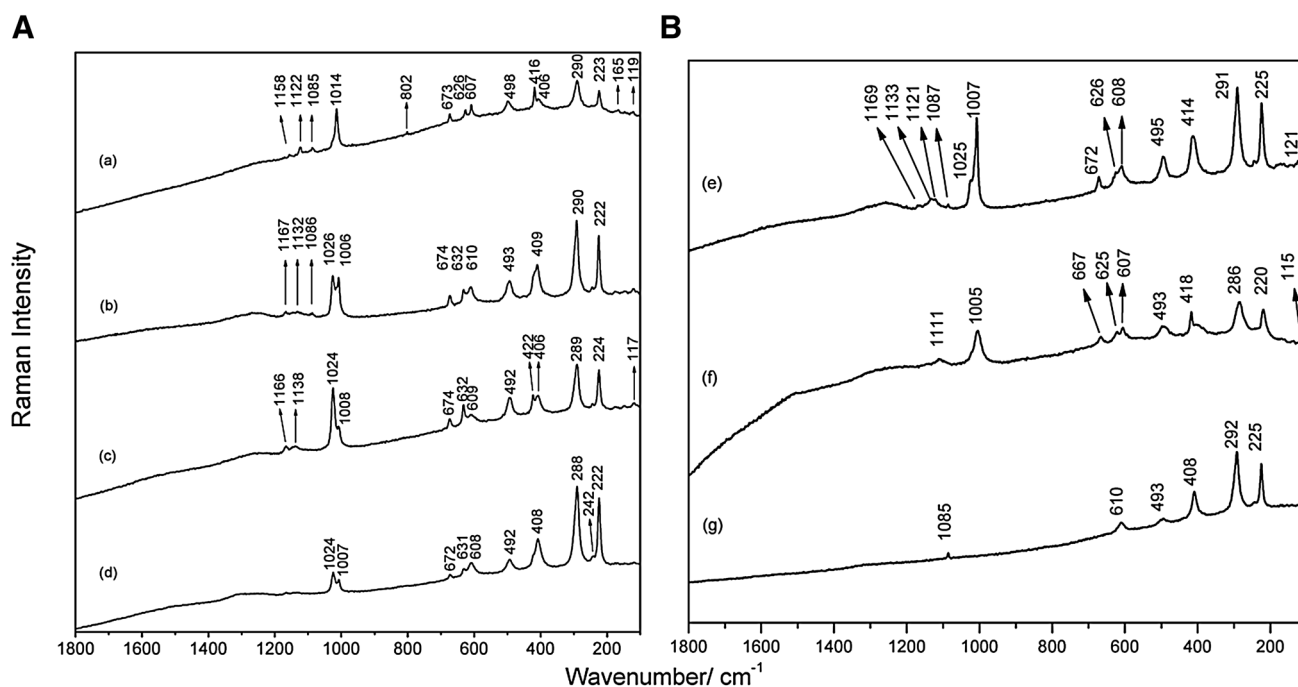
Fig. 5 **A, B** Stackplotted Raman spectra of pigment samples from "cheese" specimens from 1786 to 2008, and of the three BYN specimens: BYN 001a, BYN 001b and BYN 001 green stains. Laser excitation 785 nm in all cases; wavenumber range 100–1800 cm⁻¹

The results from an analysis of the Raman spectra are summarised in Table 1 and a selection of the spectra of pigments and grounds (referred to as “white side”) are shown in Figs. 5A, B, 6A, B and 7; the following features of interest are highlighted:

1. The red pigment used is exclusively haematite, iron (III) oxide [47]: the sharpness of the bands seem to indicate that it is quite crystalline and not adulterated with clays as in the generic “red ochres”. The usage of this pigment has not changed with decoration over the period of 220 years and haematite has been used throughout from 1786 to 2008.

5. The presence of calcium phosphate with its characteristic sharp signal at 963 cm^{-1} is noteworthy in the BYN0001 a and b specimen regions (Fig. 5)—the only location identified for this material in the current study. Calcium phosphate is the major component of calcined bone ash [54, 55] and its presence here can only be a matter of conjecture—clearly it has no relevance to the decorative pigment and its detection in wall paintings usually implies that bone black or ivory black has been used as a carbon-based pigment by the artist [2, 3]. However, there is no indication of carbon otherwise having been deliberately added to this area of the painting.

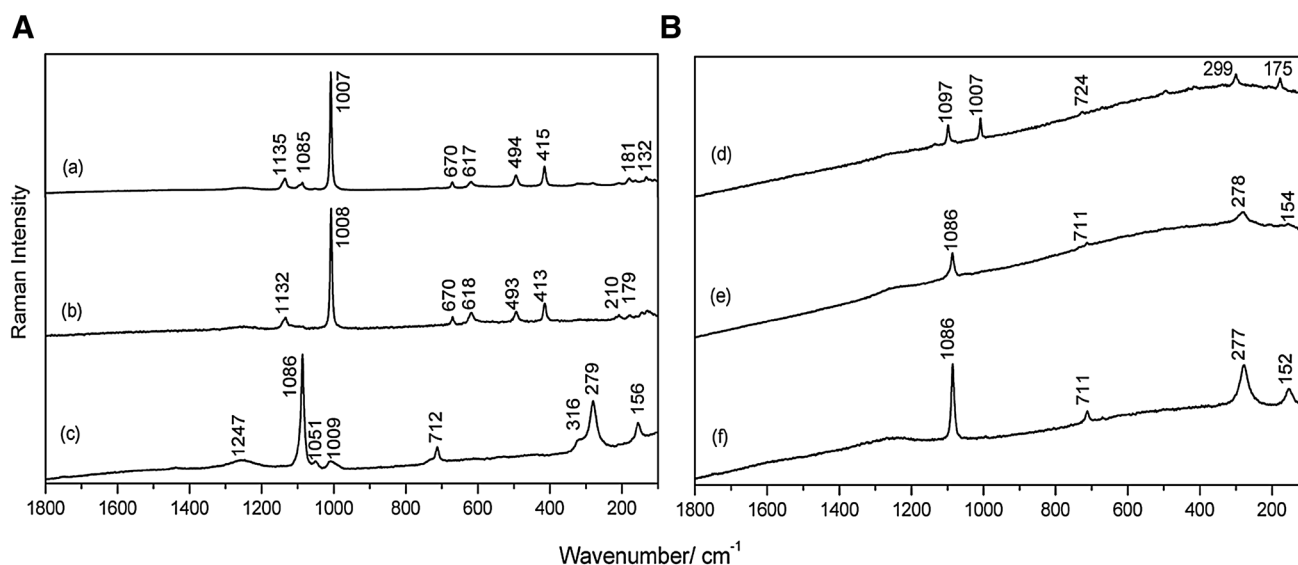
Fig. 6 A, B Stackplotted Raman spectra of ground samples from “cheese” specimens from 1786 to 2008. Laser excitation 785 nm in all cases; wavenumber range 100–1800 cm^{-1}

2. The nature of the ground deserves some comment: in 1786, signals from gypsum were detected along with those from calcite. In 1799, 1800 and 1803, only gypsum was detected, whereas in 1818 gypsum and calcite were detected together. Then, in 1852 clear signals assignable to a dolomitic limestone were found and in 1853 weak signals possibly of magnesite were detected, and finally in 2008, the last “cheese” sampled, only signals of calcite were detected [48].

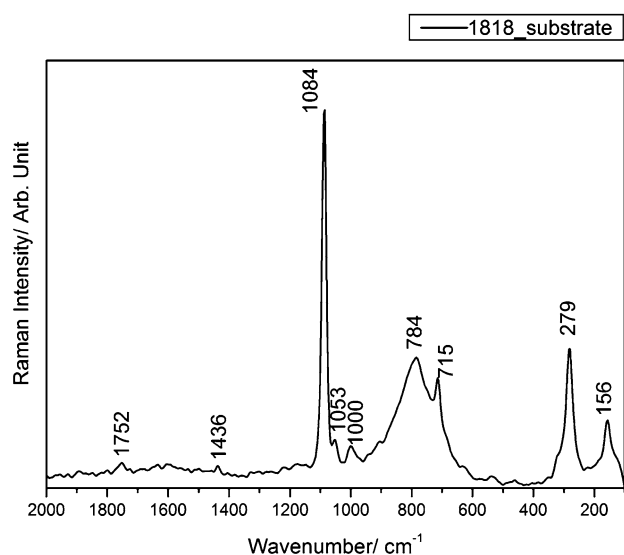
Fig. 7 FT Raman spectrum of the 1818 “cheese” substrate, 1064 nm excitation, wave number range 100–2000 cm^{-1} , showing evidence for the use of limewash putty with the broad signal at 784 cm^{-1} , which has only been partially converted into calcite

There are several important conclusions to be drawn from these spectral data: the change in composition of the white ground needs to be explained. From the earliest to the last decorative “cheese” sampled in the current study, the presence of calcite is noted: additional Raman spectra carried out with 1064 nm excitation and a Fourier Transform Raman Spectrometer clearly show the presence of limewash putty [56] remains in only the 1818 sample (Fig. 7)—this was a method of substrate preparation devised by Roman artists and is well described in the available literature. It consisted of the calcination of calcium carbonate, calcite, dolomite or aragonite, to form lime which was then partially slaked with water into a sticky moist composition and then applied as a rendering to walls and often used as a mortar from medieval period onwards. In moist conditions, exposure to atmospheric carbon dioxide then re-converted the limewash putty into a hard calcite. Here, we see evidence that this conversion has not gone to completion in

the 1818 “cheese” sample and the broad feature centred at 784 cm^{-1} assignable to an electronic excitation of calcium oxide/hydroxide confirms this, with the additional features of calcite at 1084 , 712 and 273 cm^{-1} . There are a variety of reasons to explain this observation, one of which is that the formation of an initial skin of hard, non-porous calcite has protected the underlying lime substrate from an ingress of carbon dioxide and water [37]. It is interesting that the Raman spectral signal of incomplete conversion of lime into calcite has not been found in the ground materials elsewhere: this does not mean that limewash putty usage is unique to the 1818 cheese ground preparation but rather that residual unconverted lime has been preserved here locally.
